EMW[®] Success in Difficult Carbon Slurry Application

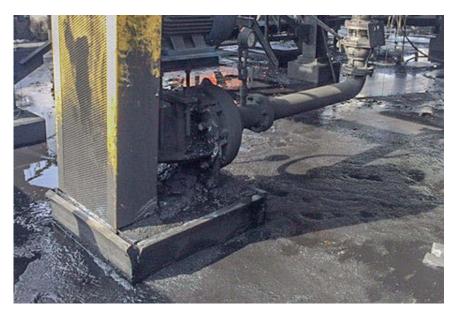
Competitor's Pump

Most importantly, the leaking carbon slurry is an environmental hazard, requiring the customer to capture, treat, and account for all leakage. The photo below shows the area under the tanks, and the leakage in the containment area.

The existing pumps worked well enough hydraulically, but had problems handling the carbon slurry due to the gland packing. The carbon slurry acts on the packing, causing it to harden-up and begin wearing the shaft sleeve. As the sleeve wears, significant leakage occurs, requiring frequent replacement of the sleeve and packing, and associated downtime, labor, etc.

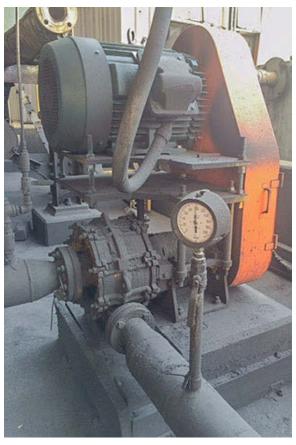
Wilfley EMW® Heavy Duty Slurry Pump

The second EMW[®] is expected to go into service in late 2015. In the below photo, you can see the dirty, but well-functioning EMW[®] in the plant. Note the containment area around the EMW[®] is completely dry.

In Spring 2015, the EMW[®] slurry pump was installed in place of the old pump and began service. Since it has been in operation, the EMW[®] hasn't experienced any operational issues in the application. It performs perfectly without a single drop of fluid from the seal, both while running at high fill levels, and while stopped.
