A.R. Wilfley and Sons, Inc.

Wilfley Solves Critical Problem in Copper Mine

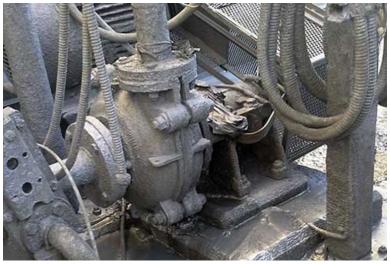
Competitor Pump

The competitor pump used traditional compression packing, which required as much as 6 gallons (23 liters) of flush water per minute to maintain proper sealing. This might not seem like much but it quickly adds up to 5,180 gallons (19,610 liters) of additional water entering the filter per day, assuming roughly 60% enters the process. The customer needed a solution and the clock was ticking until the next failure occurred.

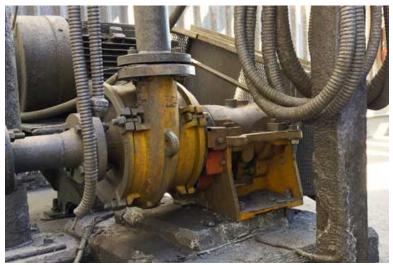
EMW[®] Slurry Pump

The solution couldn't have been simpler... replace the competitor pump with an EMW® slurry pump in MAXALLOY[®] 5A with SolidLock® sealing technology. The SolidLock[®] static seal combined with the dynamic expeller seal provides leak free operation at all times without requiring the type of flush systems that are needed for conventional sealing systems like compression packing and mechanical seals.

The EMW[®] slurry pump has now been in operation for almost a half of a year and both the pump and the pressure filter have been running trouble free. The customer is extremely happy with the outcome and can finally get a good night sleep.
