# **WITH AN AVERAGE 770 HBN AND 27.2 KSI.(INCH)<sup>1/2</sup> FRACTURE TOUGHNESS MAX5A HAS SIGNIFICANTLY INCREASED THE EQUIPMENT LIFE WHEN PUMPING PHOSPHATE ROCKS.**

George A. Calboreanu, Ph.D.  
Link Wilfley  
A.R.Wilfley & Sons. Inc. Denver, CO.

## **Abstract**

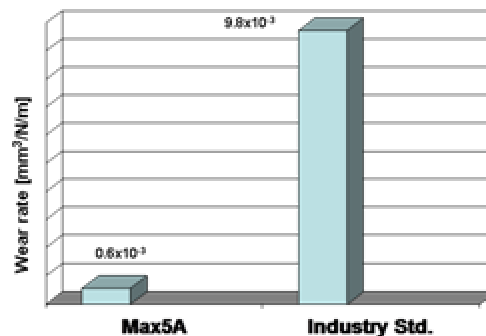
**Figure 1. Comparative wear rates of Max5A and 25% Cr Industry Standard**

The wear rate of Max5A with 780 HBN was  $0.6 \times 10^{-3}$  [mm<sup>3</sup>/N/m] versus  $9.8 \times 10^{-3}$  [mm<sup>3</sup>/N/m] the wear rate of 25% Cr Industry Standard with 650 HBN.

Total sliding distance [m] and static load [N] seen in Table 1 were utilized to calculate the wear rates [3].

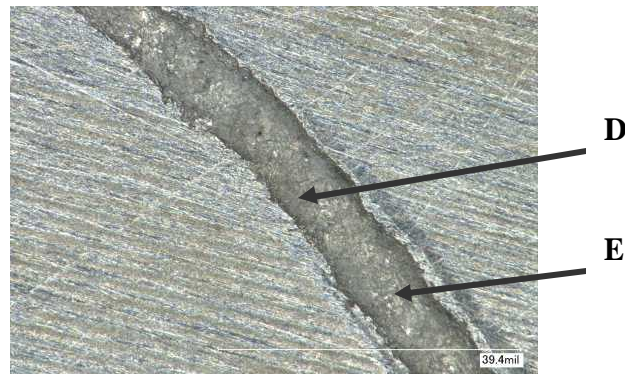
**Photo 4. SEM wear groove view of a second Max5A tested sample.**

At X2, 000 magnifications the SEM Photo 4 shows the plastically deformed wear groove contours of a second 780 HBN Max5A sample also tested with the pin-on-disk apparatus. Under the combined action of vertical load and rotational movement, compressive stresses accumulate material in front of the indenter. One such area is seen with Arrow “D”. Tensile stresses develop behind the indenter and remove material, like indicated in the example shown with Arrow “E”.

The cyclic plastic deformations of Max5A indicate elevated toughness.

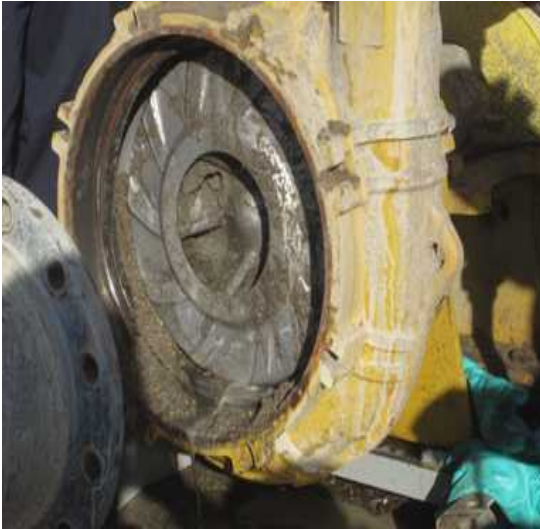
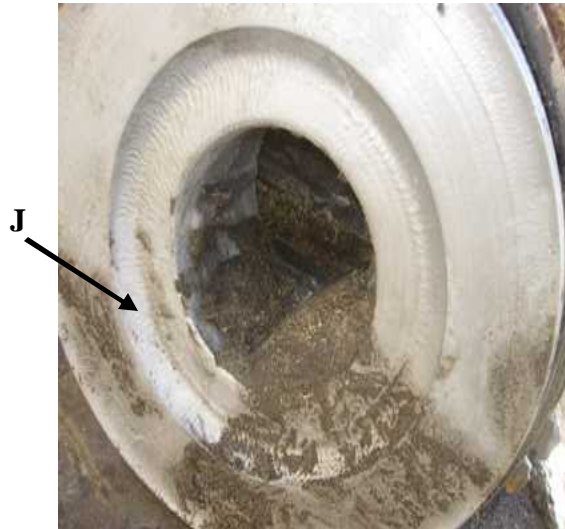
Photos 10 and 11 show the Max5A “impeller”, “pump case” and “intake cover” of the EMW 150 pump, which run successfully 24/7 for 10 months. The operation had 66% phosphate rocks with SG = 1.78 and 1,000 RPM.

**Photo 10 and Photo 11. The Photos show the excellent appearance of Max5A castings after ten continuous months of service in a Louisiana Fertilizer Plant**

Arrow “J” points to small material displacements which were previously seen on the pin-on-disk tested sample.

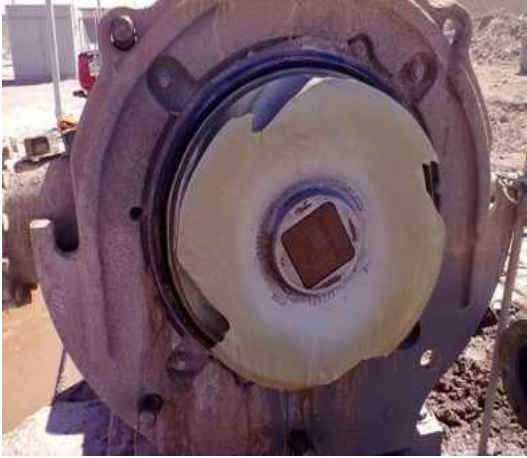
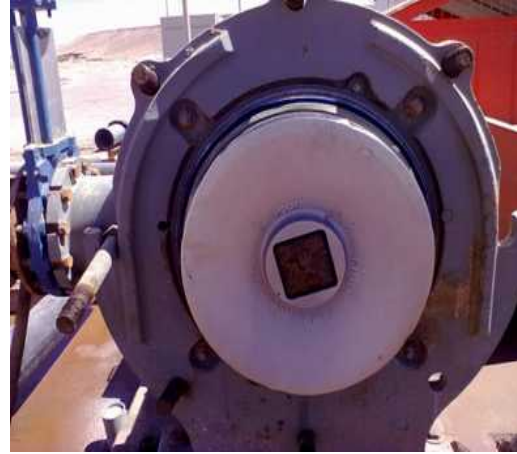
Photo 12 is a view of the backside of the old impeller after 40 days of service in a heavy mining operation. The hardness range was 620-660 HBN taken at the “impeller” OD the most wear exposed area.

Photo 13 shows the Max5A “impeller” after 97 days. The total service life was 135 days. The service life of the Max5A “impeller” increased 260% over the previously used material and by 450% over the hard iron manufactured by local suppliers.

**Photo 12 and 13 show the old “impeller” compared to the Max5A “impeller”**

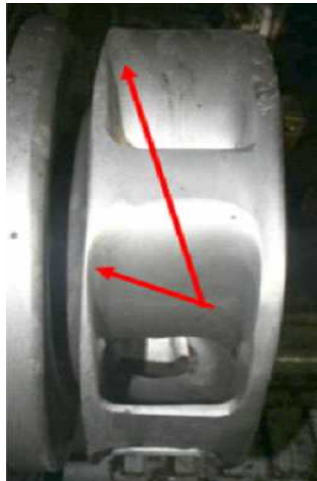
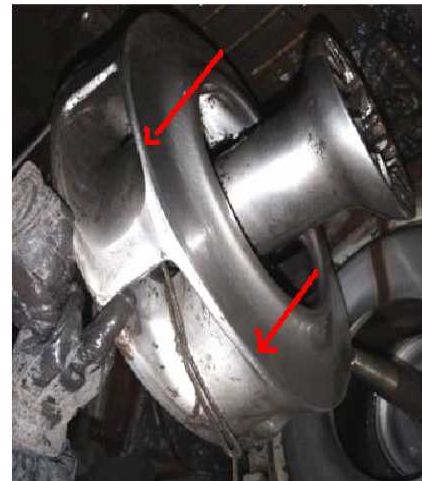
Photo 14 and 15 show two used, old “impellers”. The first “impeller” pumped 96,978 T during its 316.5 operation hours. The second “impeller” pumped 182,561 T and had 645.25 operation hours.

The arrows show the worn out “impeller” shrouds.

**Photo 14, Photo 15 and Photo 16. The first two “impellers” are poured from the old material and show severe wear. The third “impeller” is poured in Max5A and has significantly longer service life**

Photo 16 shows the Max5A “impeller” which pumped 314,480 T, during its 1,109.25 operation hours.

Considering the average performance of the old two “impellers”, the Max5A “impeller” increased production by 225% T and 231% in operating hours.

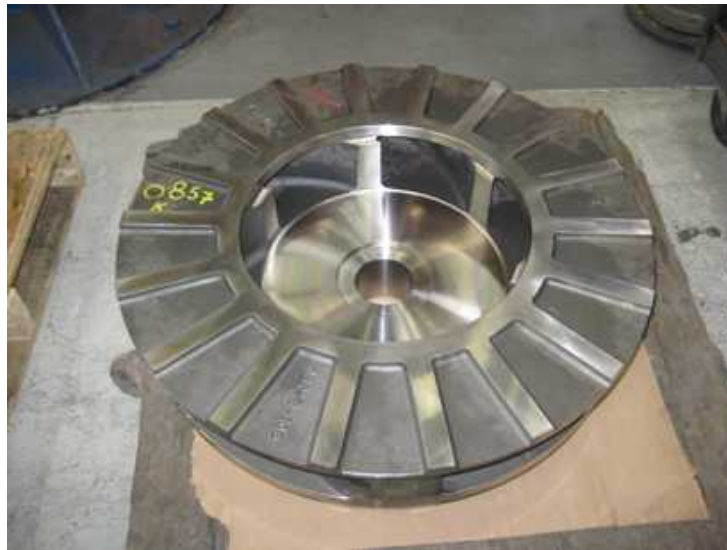
Photo 17 views a fully machined Max5A “impeller” with double pumping veins and cleaning veins.

Despite the increased hardness and the discontinuous cut machining was successfully completed.

The Max5A “impeller” pumped 120 Millions lb of sand.

**Photo 17. The fully machined Max5A “impeller” has excellent appearance**
